RE: Drinking Water Sampling – Newburg School District
701 Wolf Pride Drive
Newburg, MO 65550
Project Number: 923280

Drinking Water Assessment
Newburg School District

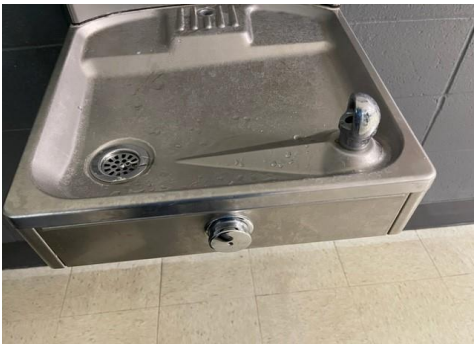
ID:	280-NSD-01	Location:	DFB		
Photo:

Manufacturer:	Elkay		
		Description:			
		Cafeteria			
		Result:	<1.0	ppb	
Recommended Action:		Date Sampled:	9/18/2023	By:	BD

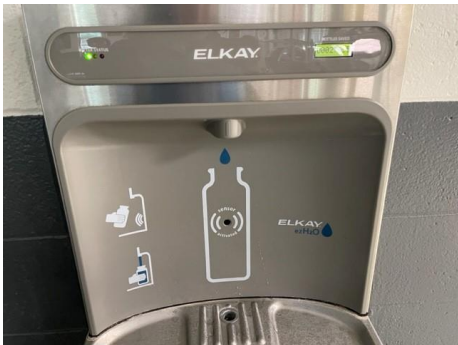
ID:	280-NSD-02	Location:	DFBF		
Photo:

Manufacturer:	Elkay		
		Description:			
		Cafeteria			
		Result:	<1.0	ppb	
Recommended Action:		Date Sampled:	9/18/2023	By:	BD

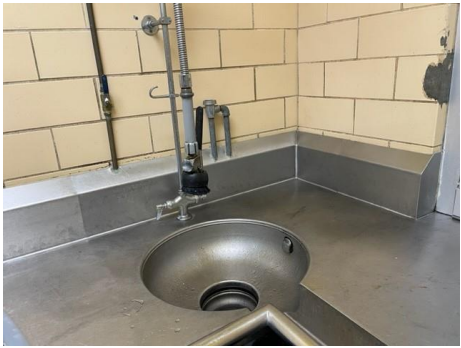
ID:	280-NSD-04	Location:	KDS
Photo:

Sample ID	Location	Type	Result (ug/L)
280-NSD-04	Kitchen	KDS	6.6
280-NSD-13	Concession stand	SNK	13.4

Manufacturer:	T&S
		Description:	
		Kitchen	
		Result:	6.6
Recommended Action:		Replace Fixture/Unit and Resample	
Date Sampled:		9/18/2023	By: BD

In accordance with the requirements set forth in Missouri Bill 681/662, fixtures exhibiting lead concentrations above 5 ppb must be remediated by replacement of lead-containing pipes, solder, fittings or fixtures with lead-free components, or the school shall install filtration at each point where water enters the building until such time as the source can be remediated. If installing a filter is not feasible, the school shall provide purified water at each outlet inventoried.

For fixtures exhibiting results above 5 ppb, follow up random “Flush” sampling shall be conducted annually on at least 25-percent of the remediated outlets until all outlets have been remediated. Drinking water sampling shall be conducted annually and annual drinking water test results shall be submitted by the district to the Department of Health and Senior Services (MDHSS).

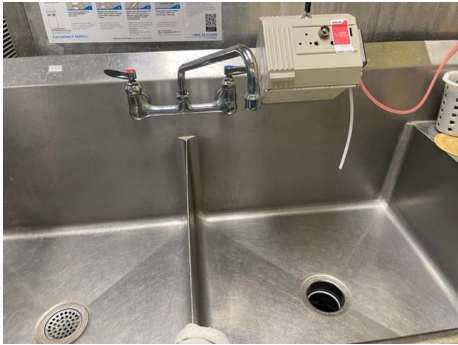
ID:	280-NSD-06	Location:	SNK
Photo:

Manufacturer:	T&S
		Description:	
		Kitchen	
		Result:	1
Recommended Action:			
Date Sampled:		9/18/2023	By: BD

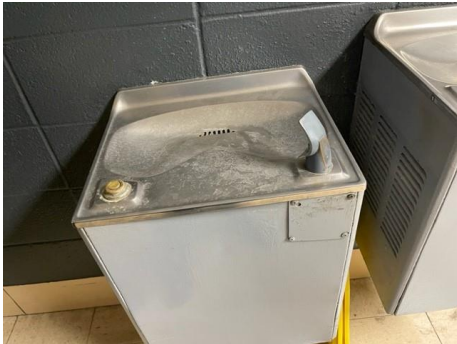
ID:	280-NSD-07	Location:	DFB		
Photo:

Manufacturer:	Unknown		
		Description:			
		Next to RM 32G, South Fountain			
		Result:	1.2	ppb	
Recommended Action:		Date Sampled:	9/18/2023	By:	BD

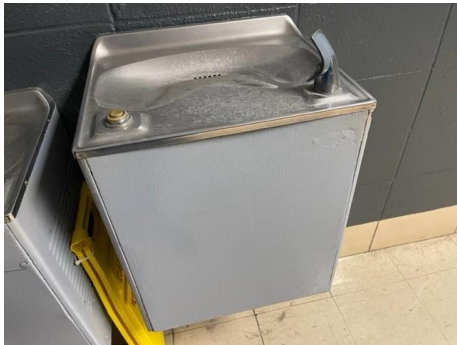
ID:	280-NSD-08	Location:	DFB		
Photo:

Manufacturer:	Unknown		
		Description:			
		Next to RM 32G, North Fountain			
		Result:	<1.0	ppb	
Recommended Action:		Date Sampled:	9/18/2023	By:	BD

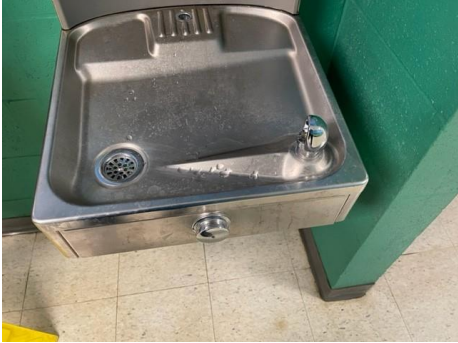
ID:	280-NSD-10	Location:	DFB		
Photo:

Manufacturer:	Elkay		
		Description:			
		Across from RM 7, West Fountain			
		Result:	<1.0	ppb	
Recommended Action:		Date Sampled:	9/18/2023	By:	BD

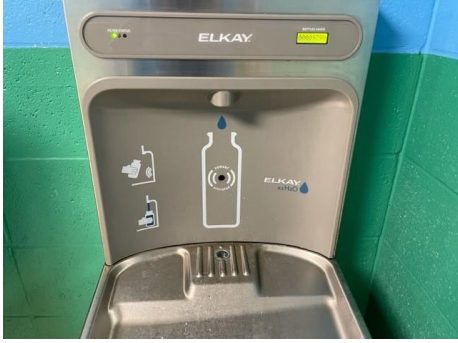
ID:	280-NSD-11	Location:	DFBF		
Photo:

Manufacturer:	Elkay		
		Description:			
		Across from RM 7, West fountain			
		Result:	<1.0	ppb	
Recommended Action:		Date Sampled:	9/18/2023	By:	BD

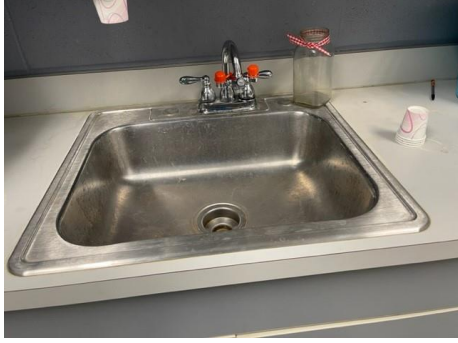
ID:	280-NSD-12	Location:	SNK		
Photo:

Manufacturer:	Moen		
		Description:			
		Nurse's Office			
		Result:	<1.0	ppb	
Recommended Action:		Date Sampled:	9/18/2023	By:	BD

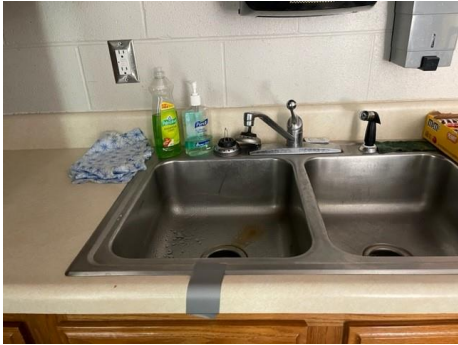
ID:	280-NSD-13	Location:	SNK
Photo:

Manufacturer:	Delta
		Description:	
		Concessions Sink, Leaking	
		Result:	13.4
Recommended Action:		Replace Fixture/Unit and Resample	
		Date Sampled:	9/18/2023 By: BD

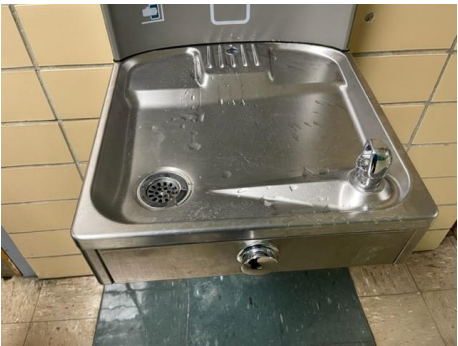
ID:	280-NSD-14	Location:	DFB
Photo:

Manufacturer:	Elkay
		Description:	
		Across from RM 55	
		Result:	<1.0
Recommended Action:			
		Date Sampled:	9/18/2023 By: BD

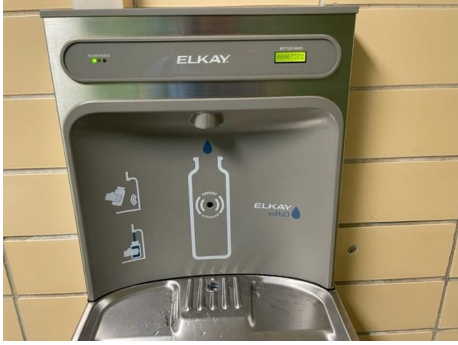
ID:	280-NSD-15	Location:	DFBF
Photo:

Manufacturer:	Elkay
		Description:	
		Across from RM 55	
		Result:	<1.0
Recommended Action:			
		Date Sampled:	9/18/2023 By: BD

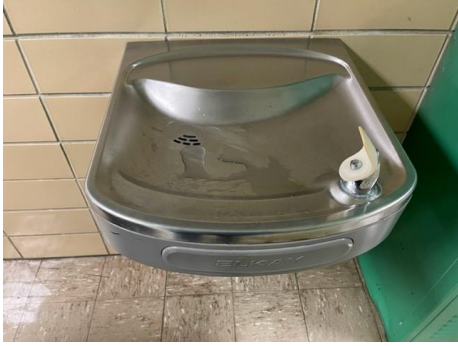
ID:	280-NSD-16	Location:	DFB	
Photo:

Manufacturer:	Elkay	
		Description:		
		Across from RM 57		
		Result:	1.3	ppb
		Date Sampled:	9/18/2023	By: BD
Recommended Action:

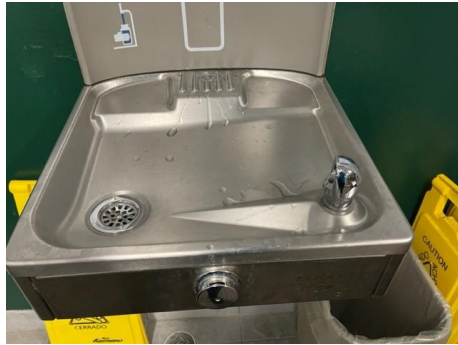
ID:	280-NSD-17	Location:	DFB	
Photo:

Manufacturer:	Elkay	
		Description:		
		Gym		
		Result:	<1.0	ppb
		Date Sampled:	9/18/2023	By: BD
Recommended Action:

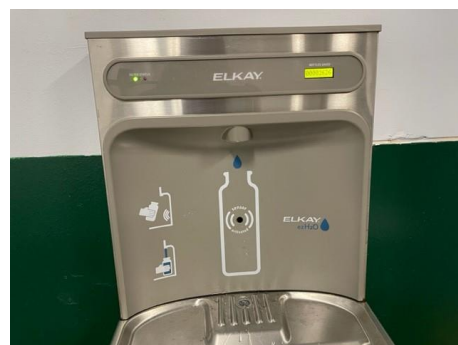
ID:	280-NSD-18	Location:	DFBF	
Photo:

Manufacturer:	Elkay	
		Description:		
		Gym		
		Result:	<1.0	ppb
		Date Sampled:	9/18/2023	By: BD
Recommended Action:

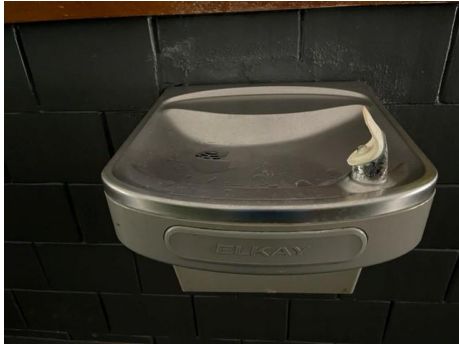
ID:	280-NSD-19	Location:	DFB		
Photo:

Manufacturer:	Elkay		
		Description:			
		Across from RM 72			
		Result:	<1.0	ppb	
Recommended Action:		Date Sampled:	9/18/2023	By:	BD

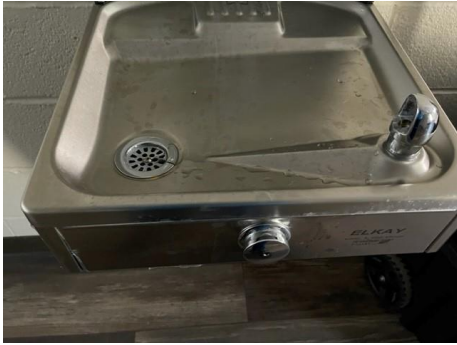
ID:	280-NSD-20	Location:	DFB		
Photo:

Manufacturer:	Elkay		
		Description:			
		Ag Building			
		Result:	<1.0	ppb	
Recommended Action:		Date Sampled:	9/18/2023	By:	BD

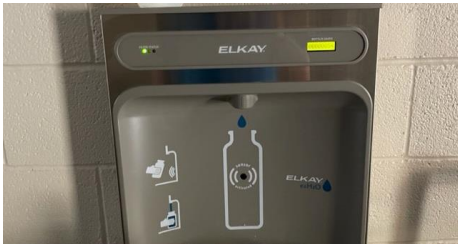
ID:	280-NSD-21	Location:	DFBF		
Photo:

Manufacturer:	Elkay		
		Description:			
		Ag Building			
		Result:	<1.0	ppb	
Recommended Action:		Date Sampled:	9/18/2023	By:	BD

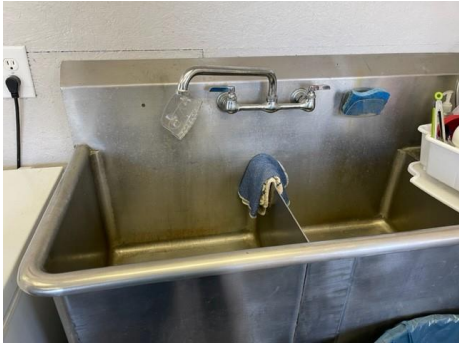
ID:	280-NSD-22	Location:	SNK	
Photo:

Manufacturer:	Unknown	
		Description:		
		Baseball Concessions		
		Result:	3.2	ppb
		Date Sampled:	9/18/2023	By: BD
Recommended Action:
